**Site/Project Location:** MP 118.5 Spread 9, M.P. 1.5 & 42 Spread 8 **Date of Inspection:** 29 September 2016

Pipeline ROW going through tree/shrubs near Arnegard and Dunn Center in McKenzie and Dunn County.

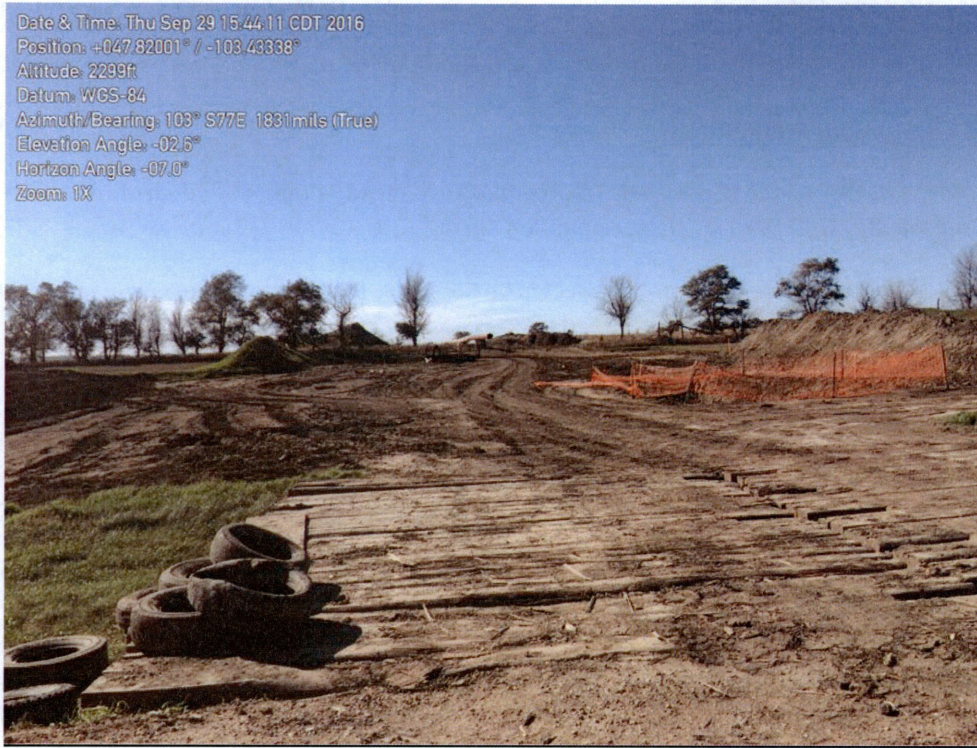
**Report Photo #1 "Tree row at M.P. 118.5 Spread 9":**

Tree removal was confirmed to be 85 feet or less at M.P. 118.5 Spread 9 and M.P. 42 Spread 8. These areas were proposed to be cleared the full 150' based on shape files received from the ND Public Service Commission. As reported on September 1, 2016, M.P. 1.5 Spread 8 had trees and shrubs were cleared 127 feet at the narrowest visible width. All shrubs removed were completely stripped during topsoil removal and were not cut flush with ground. Shrub species noted and observed were silver buffaloberry and chokecherry.

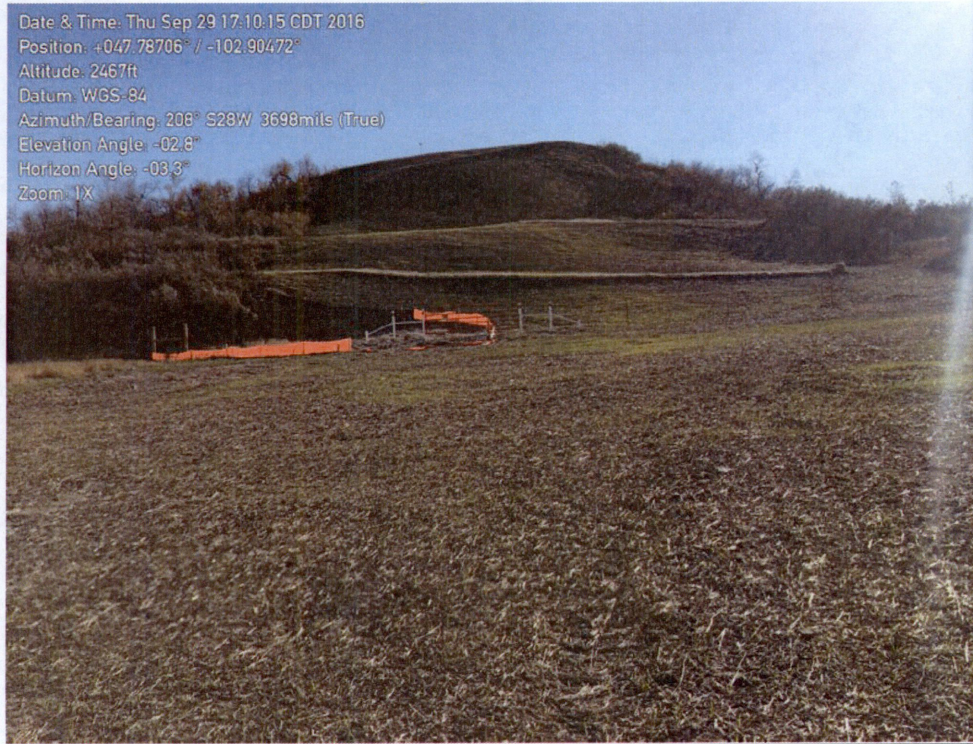
**Report Photo #3 "Tree Clearing at M.P. 1.5 Spread 8":**

As noted on September 1, 2016, tree/shrub removal extended significantly beyond 85 feet approved at M.P. 1.5 Spread 8. Shrubs were observed and documented on the ROW edges. Further investigating should occur whether these tree/shrubs were surveyed. Shrubs outside the permanent ROW may be mitigated by natural regeneration if: shrubs are cut flush the surface of the ground and if the native topsoil is preserved, but that was not the observed condition i.e. shrubs cleared at M.P. 1.5 on Spread 8 were not cut flush with the ground

Further investigation should occur to see if approved May 2016 reroutes were surveyed for trees/shrubs.
